# NEW MEXICO ENVIRONMENT DEPARTMENT

**Re:** Silver City Waste Water Treatment Facility, MSGP, SIC 4952, NPDES Compliance Evaluation Inspection, NMR053019, January 19, 2017

#### **NPDES Compliance Inspection Report**

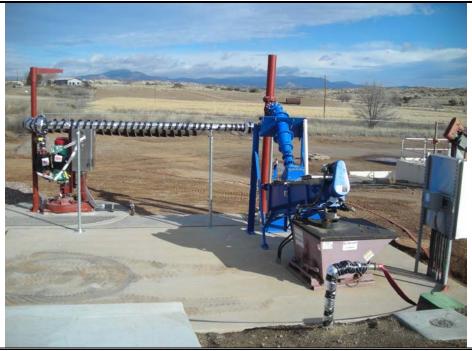
NMED/SWQB Official Photograph Log Photo # 1					
Photographer: J. Foote	Date: 1/19/2017				
City/County: Silver City, Grant Co.	State: New Mexico				
Location: Silver City WWTP					
Subject: New covered waste container at headworks

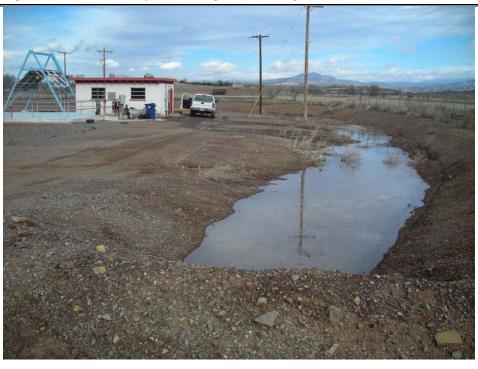
SWPPP Implementation					
Spill Prevention and Response	(e.g., minimizing the potential for leaks, spills and other releases that may be exposed to storm water and develop plans for effective response to such spills if or when they occur)				
	Spill procedures and response are discussed in SWPPP. No documentation in SWPPP of any spill event occurring.				
Erosion and Sediment Controls	(e.g., stabilize exposed areas and contain runoff using structural and/or non-structural control measures to minimize onsite erosion and sedimentation, flow velocity dissipation devices at discharge locations and within outfall channels)				
	Site is open to rainwater, area below culverts is stabilized with asphalt.				
Management of Runoff	(e.g., divert, infiltrate, reuse, contain, or otherwise reduce storm water runoff, to minimize pollutants in discharges)				
	Retention pond in place to collect rainfall runoff from north portion of site. (Photo 2) South side does not have berm in place.

NMED/SWQB Official Photograph Log Photo # 2					
Photographer: J. Foote						
City/County: Silver City, Grant Co.	City/County: Silver City, Grant Co. State: New Mexico					
Location: Silver City WWTP						
Subject: Berm and retention pond on North east side of facility. Water is from potable reuse line repair.

Multiple reference were made regarding the failure to install a berm to control runoff. The Town of Silver City will have the berm installed following completion of an engineered grading and drainage plan.

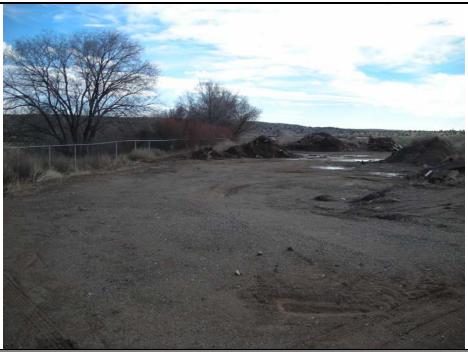
SWPPP Implementatio	n				
Waste, Garbage and Floatable Debris	(e.g., keep exposed areas free of such materials or by intercepting them before they are discharged)				
	Junk and waste piles on south side of site in unbermed area needs to be disposed of or secured. (photo 3)				
	Control Measure Maintenance log indicated uncovered trash bins were replaced with covered bins in September 2012 and the grit chamber bin was replaced with a covered bin in October 2012(photo 1).				
Evidence of non- storm water discharges					
	Reuse water was discharging from a pipe for a meter replacement, but was all contained by the retention pond(photo 2).				
Dust Generation and Vehicle Tracking of Industrial Materials	(minimize generation of dust and off-site tracking of raw, final, or waste materials)				
	Maintenance log indicated drying beds are checked for tracked materials once a week and cleaned as needed.

NMED/SWQB Official Photograph Log Photo # 3					
Photographer: J. Foote	Date: 1/19/2017				
City/County: Silver City, Grant Co.		State: New Mexico			
Location: Silver City WWTP					
Subject: Debris storage piles, southeast side of facility with no berm, drains by sheet flow with some water retained in puddles.

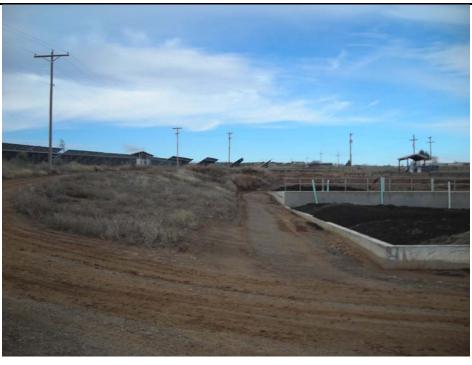
NMED/SWQB Official Photograph Log Photo # 4					
Photographer: J. Foote					
City/County: Silver City, Grant Co. State: New Mexico					
Location: Silver City WWTP					
Subject: sludge overtopped sludge bed wall.

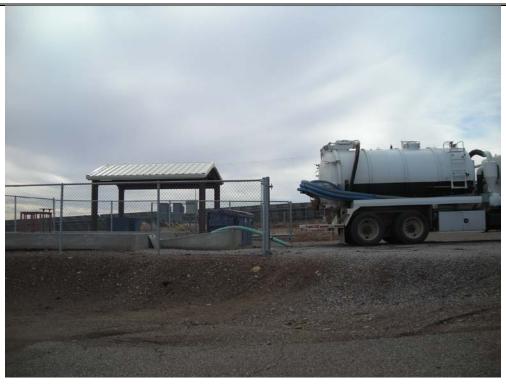
#### NMED/SWQB Official Photograph Log Photo # 6

Notes on SWPPP Review
Site Description:
The Silver City Wastewater Treatment Plant (WWTP) is 13 acres, the site slopes from west to east. The north and northeast side of the facility is bermed to prevent the San Vicente from flooding onto the plant grounds. There is a retention pond on the northeast side, with no visible outlet. There are storm drains that bring water from the entrance road to an asphalt area in between the drying beds that leaves the site as sheet flow through a bare soil area. The septage receiving area has been stabilized with gravel. Except for the entrance driveway, the surrounding area is undeveloped vegetated grass/shrub.
The SWPPP map shows a "proposed berm" on the southeast side that was never installed. Currently water (and potentially pollutants) from the sludge bed area and septage receiving leave the site without BMPS from this area. (photo 6) There is no way to sample runoff from the sheet flow discharge from this area.

Subject: stabilized septage receiving area, hose outside of containment could allow septage onto the ground
